**WHITEHEAD ENVIRONMENTAL
CONSULTANTS LTD.**

29 July 2009
Project File: 109-2

RE: BIOPHYSICAL ASSESSMENT OF THE BELTERRA PROPERTY, BOWEN ISLAND.

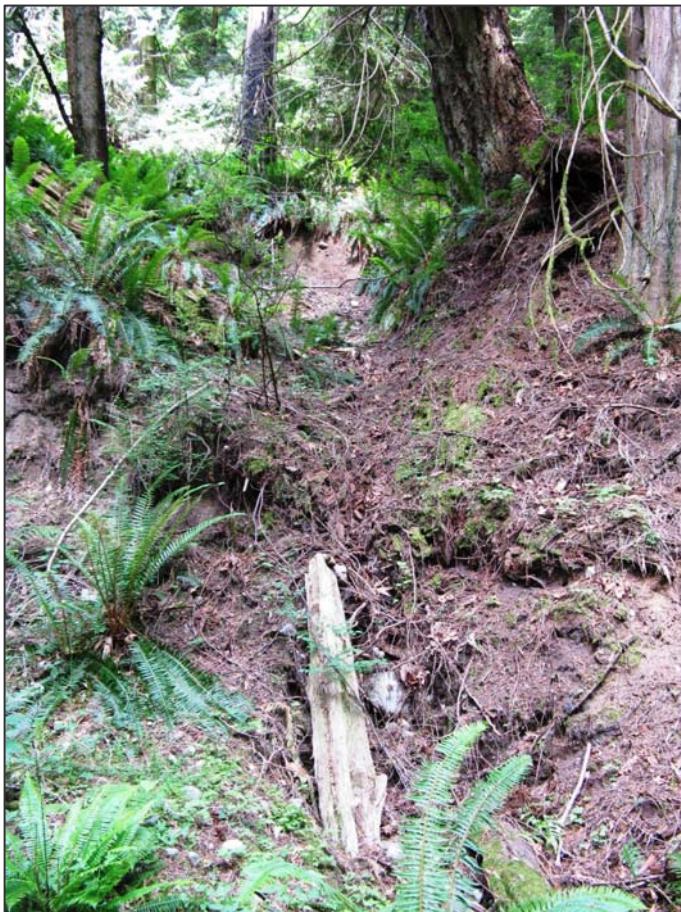
The lower half of the property below the driveway drains directly to the Terminal Creek ravine within the Belterra lands. Runoff occurs as dispersed or sheet flow over the surface and soon becomes shallow groundwater in uppermost layer of the forest soils; as a result, there are no defined water courses in this area. Some of the shallow groundwater emerges as surface water seeps at the toe of the ravine beside the pipeline corridor, and again soaks into the ground on its route to the aquifer below Terminal Creek. An area of unstable slope was observed on the steep ravine bank in the southwest portion of the property. At slump this site appears to have occurred as a result of saturation of the surface soils by shallow groundwater (Fig. 2; Photo 19)

Photo 19. Unstable slope on south side of Terminal Creek ravine near west boundary of Belterra property. 19-Jun-09

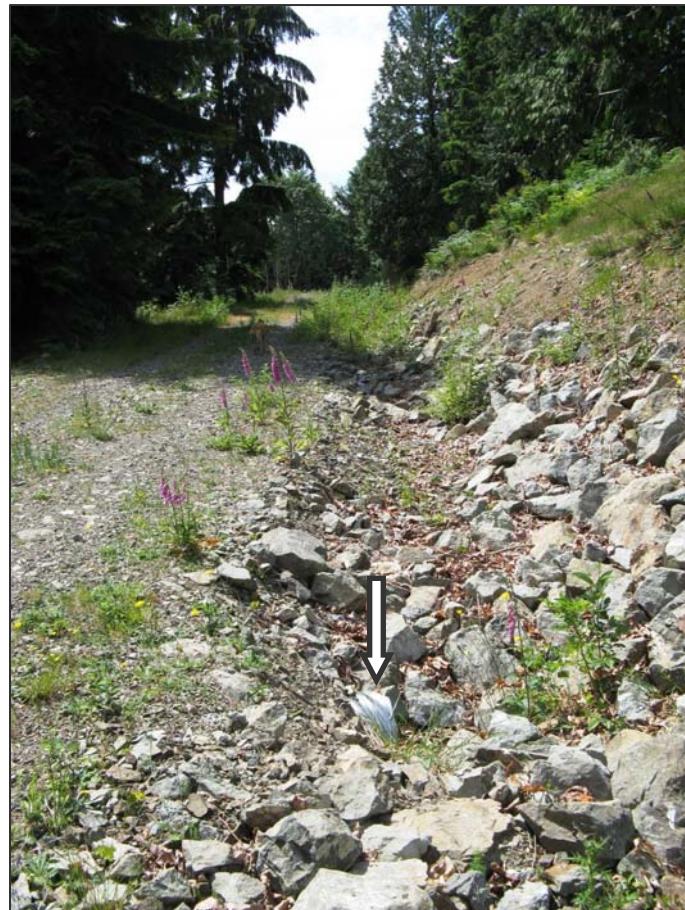
Drainage from the upper half of the property is intercepted by a ditch (Photo 20) along the ascending leg of the driveway and directed to two point discharges, one to Terminal Creek ravine above Carter Pond, and the other below Carter Road (Fig. 2). The upper drainage is conveyed under the driveway opposite the IPS parking area (Photo 21) and then follows a shallow ditch along the west side of the parking lot (Photo 22) and ultimately discharges to the ravine (Photo 23); the remains of two abandoned silt fences were observed at the discharge point (Photo 24).

Photo 20. Drainage “ditch” along north side of driveway into Belterra property, viewed upstream from upper culvert (arrow). This driveway is also used as a trail to the Camp Bow-Isle lands.

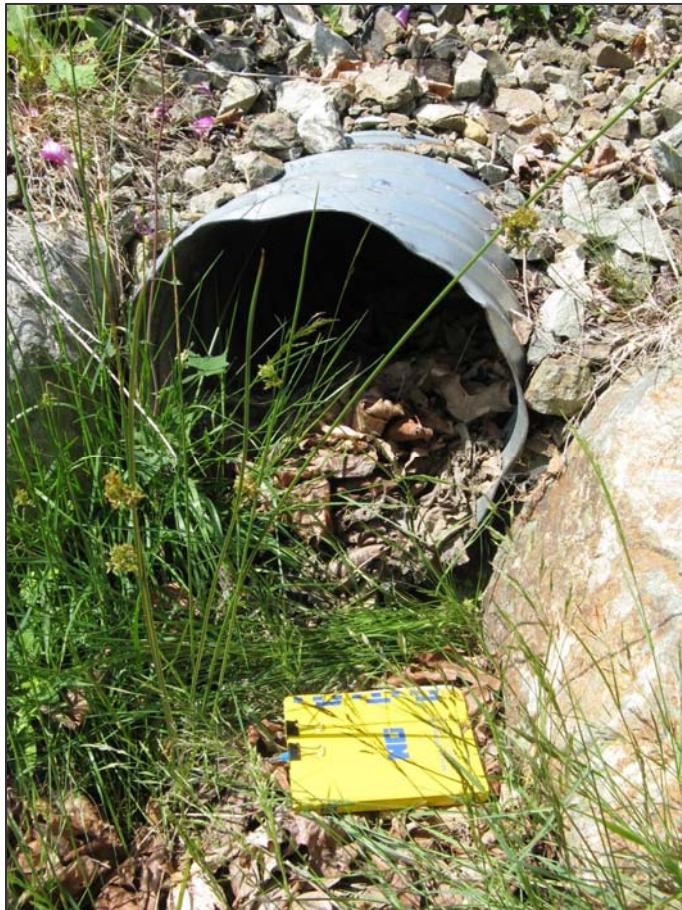
Photo 21. Outlet of upper culvert on Belterra driveway. Discharge from this culvert ultimately discharges to Terminal Creek ravine near east boundary of the property. 19-Jun-09

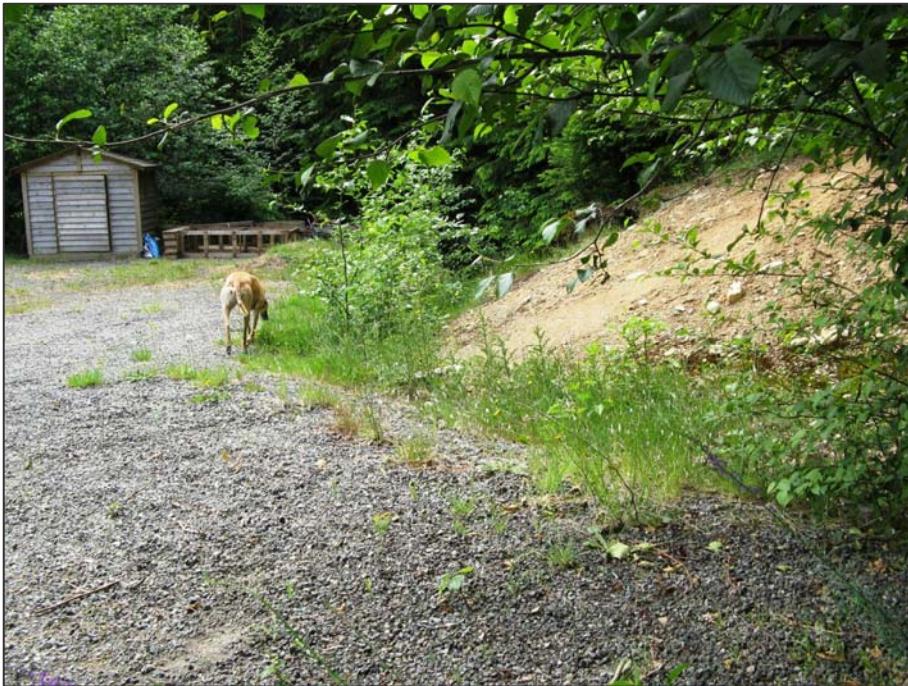
Photo 22. Stormwater "ditch" along west side of IPS parking area, viewed to south. This ditch receives runoff from most of the upper Belterra property and ultimately discharges to Terminal Creek ravine near east boundary of the property. 19-Jun-09

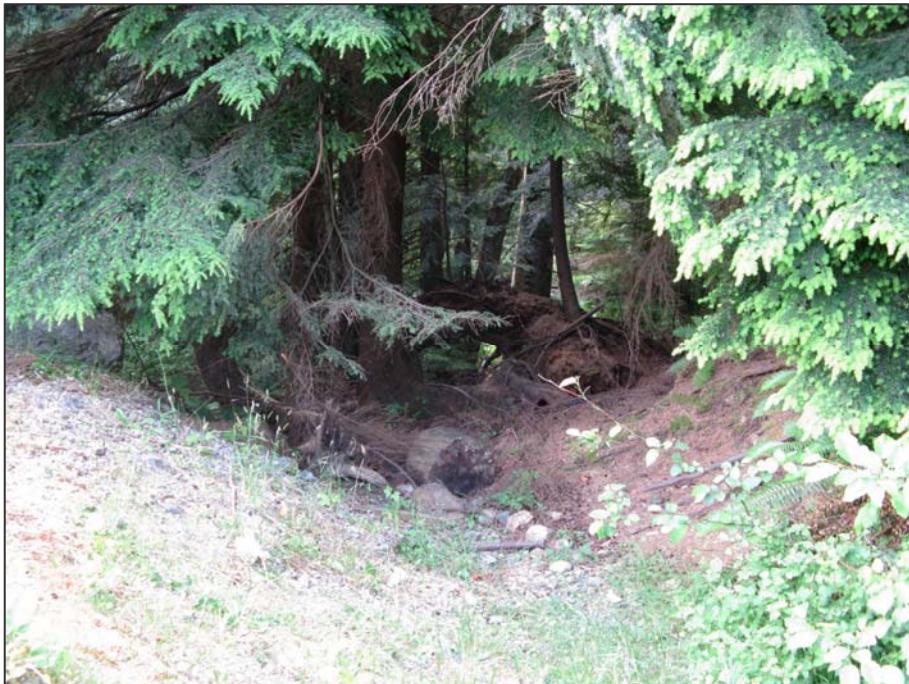
Photo 23. Discharge point of upper stormwater ditch to Terminal Creek ravine immediately south of IPS parking lot. This location is start of trail to bottom of ravine. 19-Jun-09

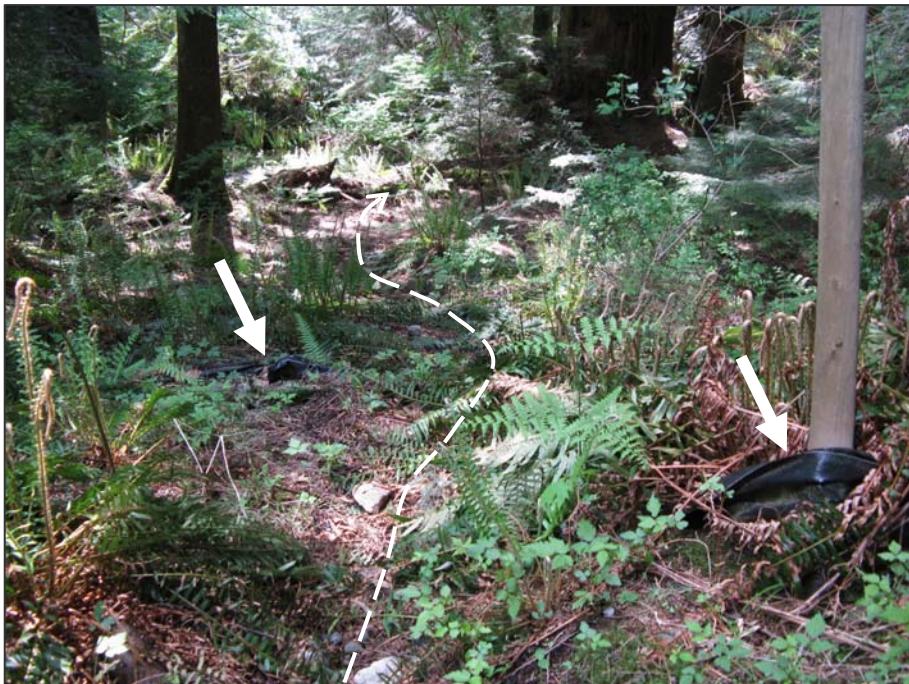
Photo 24. Abandoned silt fencing (arrows) along stormwater discharge route within Terminal Creek ravine. Dashed arrow denotes stormwater route when flow is present. This site is within the IPS property immediately east of Belterra lands. 19-Jun-09

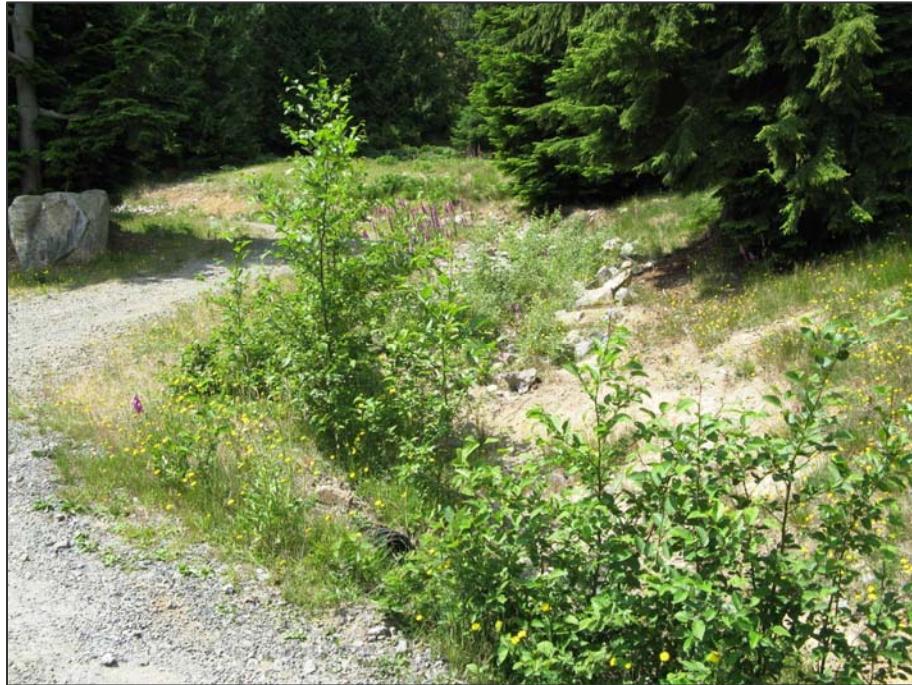
The lower drainage follows a shallow ditch beside the driveway (Photo 25), is culverted under Carter Road (Photos 26 and 27) and discharged to the top of the slope above the Municipal Works Yard. An overgrown swale at the foot of this slope (Photo 28) conveys seasonal runoff eastward toward Terminal Creek below the lower falls. Judging by the indistinct channel that has formed on the ravine banks below both discharges, it is evident that the volumes of runoff are typically very low. However, sediment has accumulated in the flatter portions of the ditches (reducing their capacity), and rills have been scoured into the surface soils on the steep banks, exposing vegetation roots (Photos 29 and 30).

Photo 25. Stormwater ditch along lower driveway in Belterra lands, viewed from entrance to IPS parking lot. 19-Jun-09

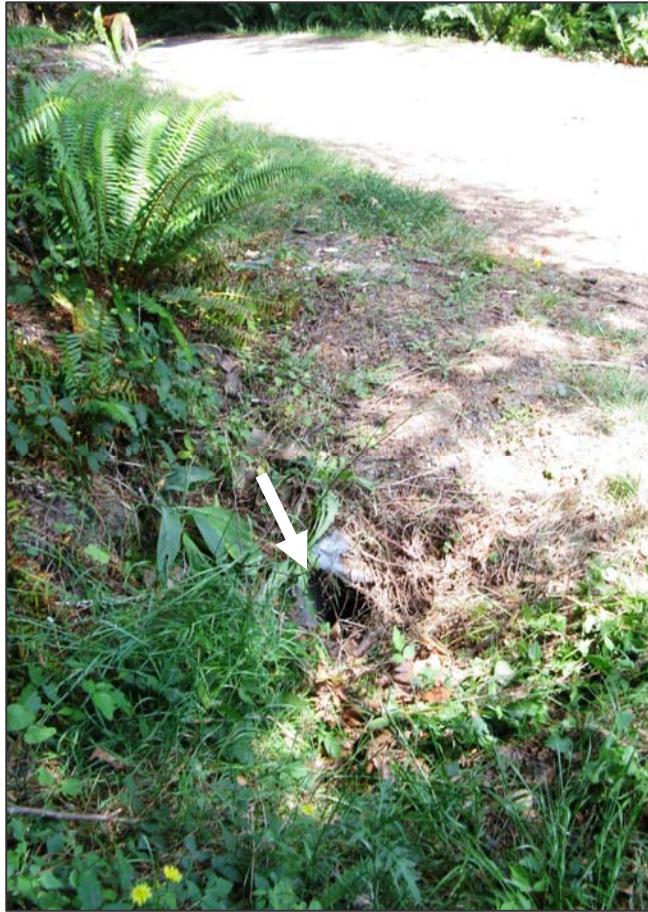
The above observations indicate that (a) there is a risk of flooding the roadbed during heavy rainfall due to sediment build-up in the ditches and/or blockage of the culvert, and (b) significant erosion can occur during periods of peak runoff such as very heavy rainstorms and rain-on-snow events. Over time, the loss of vegetation cover coupled with continued seasonal peak flows can lead to the formation of unstable gullies and, potentially, sedimentation of aquatic habitat within Terminal Creek.

Photo 26. Culvert (arrow) under Carter Road at bottom of Belterra driveway, viewed to north. Note accumulated vegetation and leafy debris at culvert inlet. 19-Jun-09

- d. provide sediment traps at the inlets of the culverts under the driveway and Carter

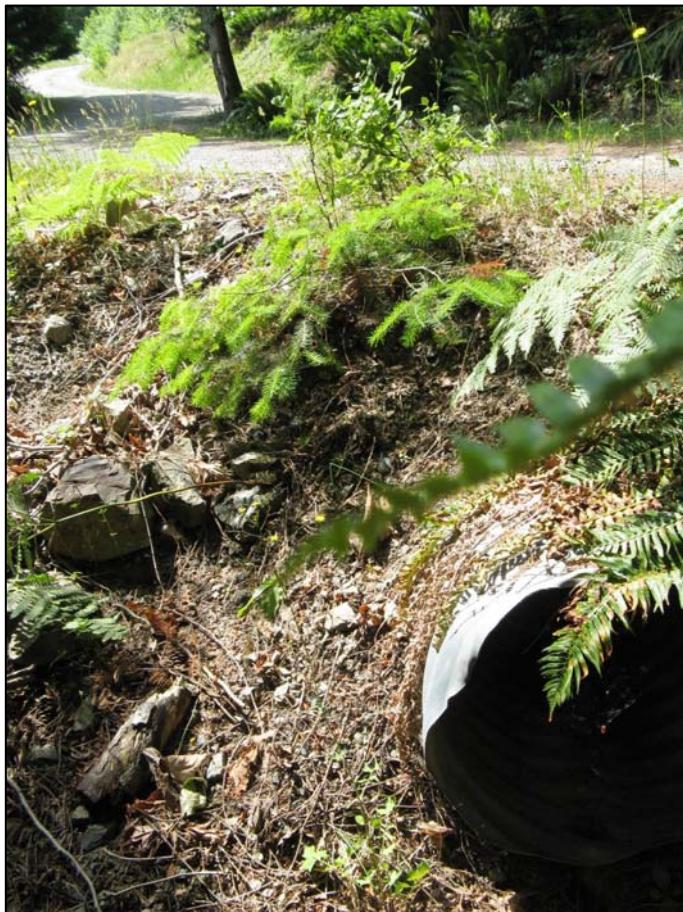
Photo 27. Outlet of culvert under Carter Road, viewed toward Belterra driveway. This culvert carries all drainage from the lower and eastern half of the Belterra lands.

- e. provide rock armour below the culvert outlets for energy dissipation, and other means of preventing erosion on the steep banks below these discharges; and
- f. incorporate yearly inspection and maintenance of all ditches, sediment traps and culverts into the project operations .

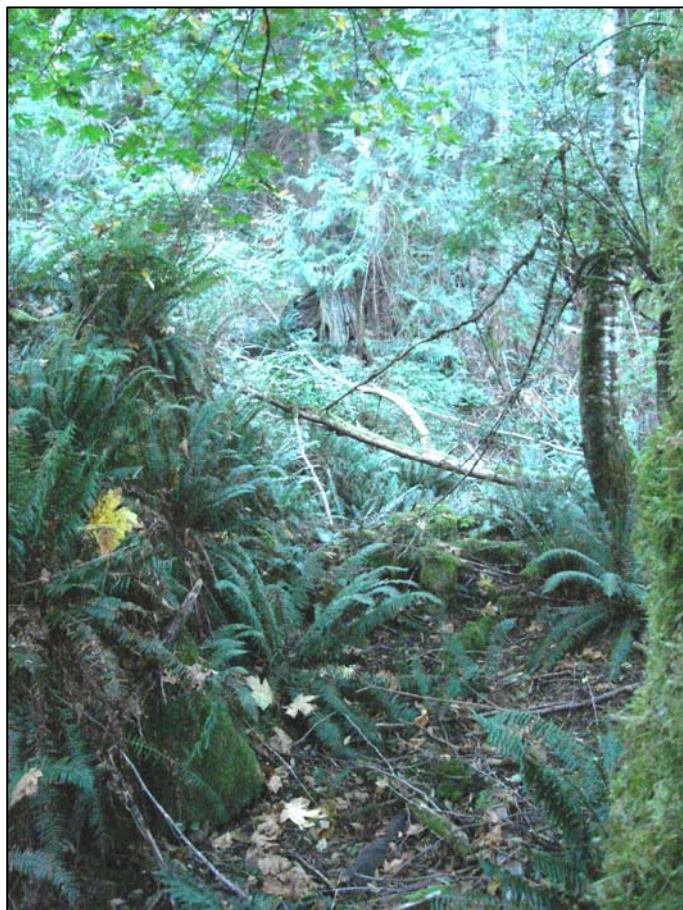
Photo 28. Shallow drainage channel at foot of slope below the culvert shown in previous photo. This channel ultimately discharges to Terminal Creek beside the Municipal Works Yard. Note accumulation of woody debris and leaves which suggest absence of significant flows.

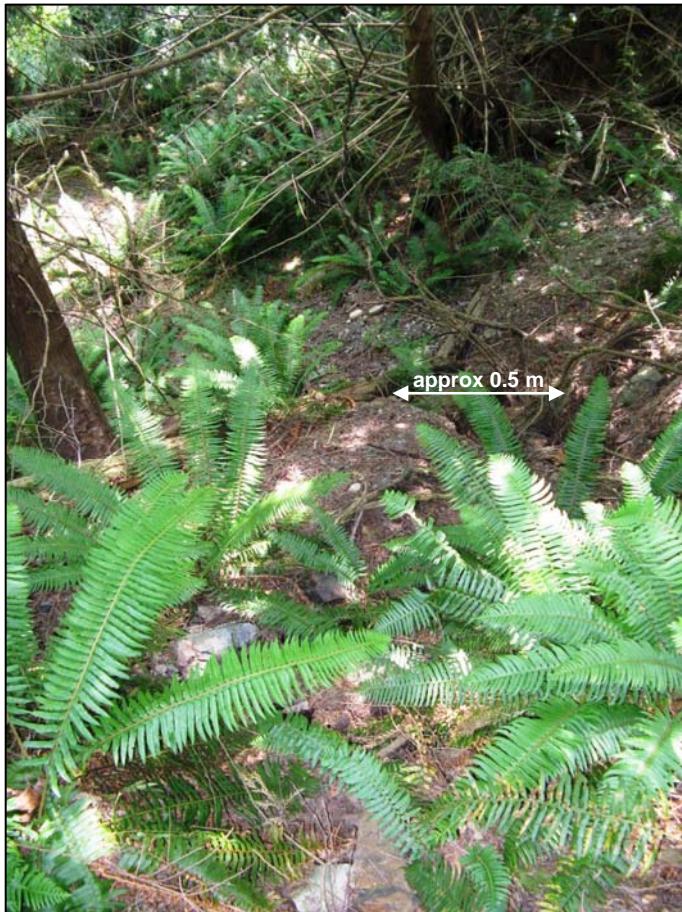
Photo 29. Minor erosion of ravine bank below Carter Road culvert outlet. Note exposed roots. 19-Jun-09

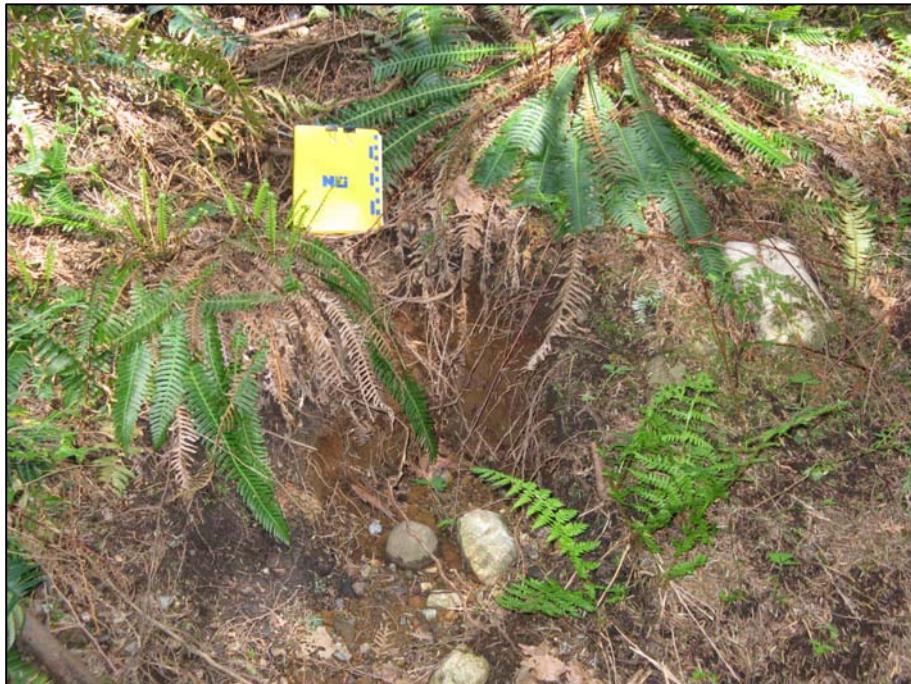
Photo 30. Minor erosion of Terminal Creek ravine bank below IPS parking lot stormwater discharge. Note exposed roots. 19-Jun-09
